CTPS Technical Memorandum: Proposed Improvements for Saltonstall School Crossings

Transportation Improvement Study

for Routes 1A, 114, and 107 and Other Major Roadways in Downtown Salem

RE: Proposed Improvements for Saltonstall School Crossings

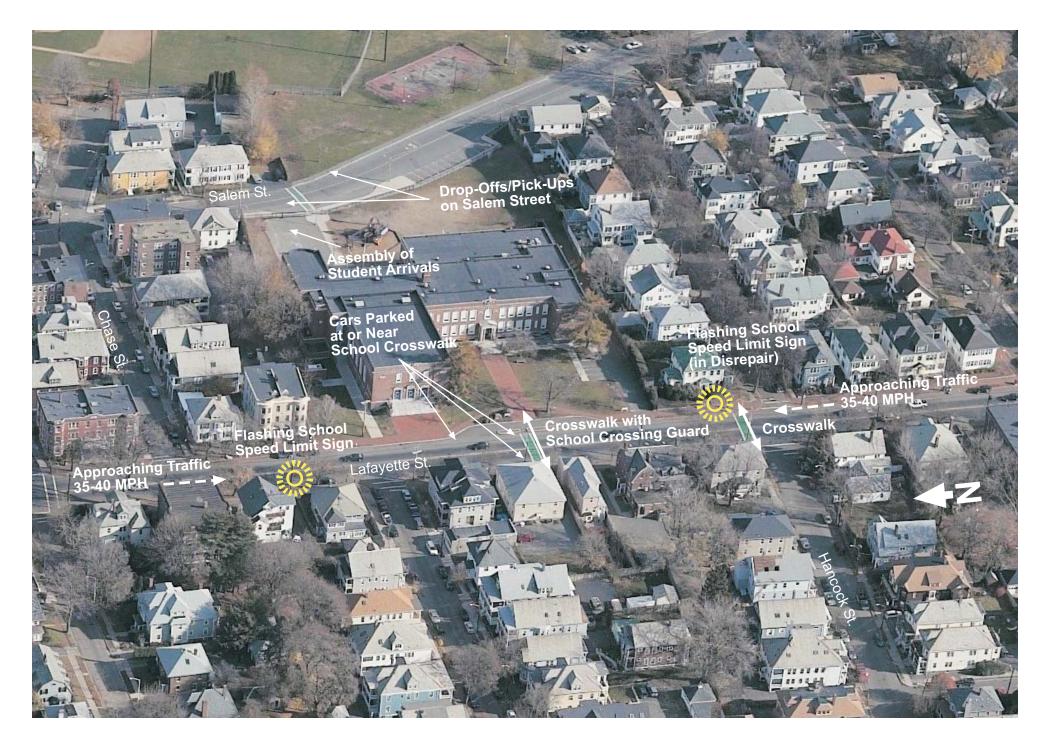
Figure 1 Existing Conditions

CTPS conducted a field reconnaissance on March 18, 2005, from 7:30 AM to 8:00 AM. The weather was clear and cold. During the reconnaissance, staff observed traffic conditions and pedestrian activity on Lafayette Street. They also took note of the roadway conditions, pavement markings, and signs in the school vicinity. The observations are summarized below (see Figure 1 for locations of some of the observations):

- Flashing school speed limit (20 MPH) signs are installed on Lafayette Street both north and south of the school property. The flashing sign on the south side was not functioning during the observation period.

• On-street parking is allowed on both sides of Lafayette Street. Cars were parked at the island that separates a pull-out area in front of the school entrance from the northbound traffic. The pull-out is used by school buses/vans to pick up students after school. Also, cars were parked very close to the pull-out exit and on the southbound side close to the main crosswalk. These cars could potentially obstruct the view of motorists on Lafayette Street.

"End School Zone" signs³ (indicating permission to resume the normal speed limit on the street) should be installed in addition to school speed limit signs. At the Saltonstall School, only the school speed limit signs are installed, and the one on the south side facing the northbound traffic is located too close to the school property. The present signs are insufficient to warn and slow the approaching traffic.

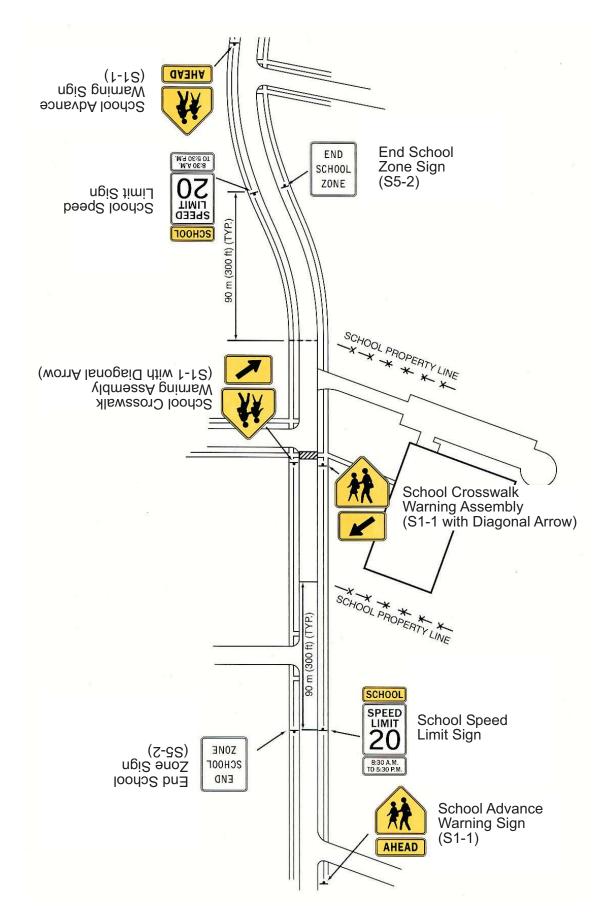
Figure 2 Typical Signing for School Area Traffic Control

To ensure student safety, school crossings are usually accompanied by a series of control devices to warn and slow the traffic approaching the designated school zone. The purpose is to slow traffic in the vicinity of school property, not just at the crossing location. Figure 2 shows a typical signing arrangement for school area traffic control. As shown, school advance warning signs¹ (showing school ahead), school crosswalk warning assembly² (showing a designated school crosswalk), and

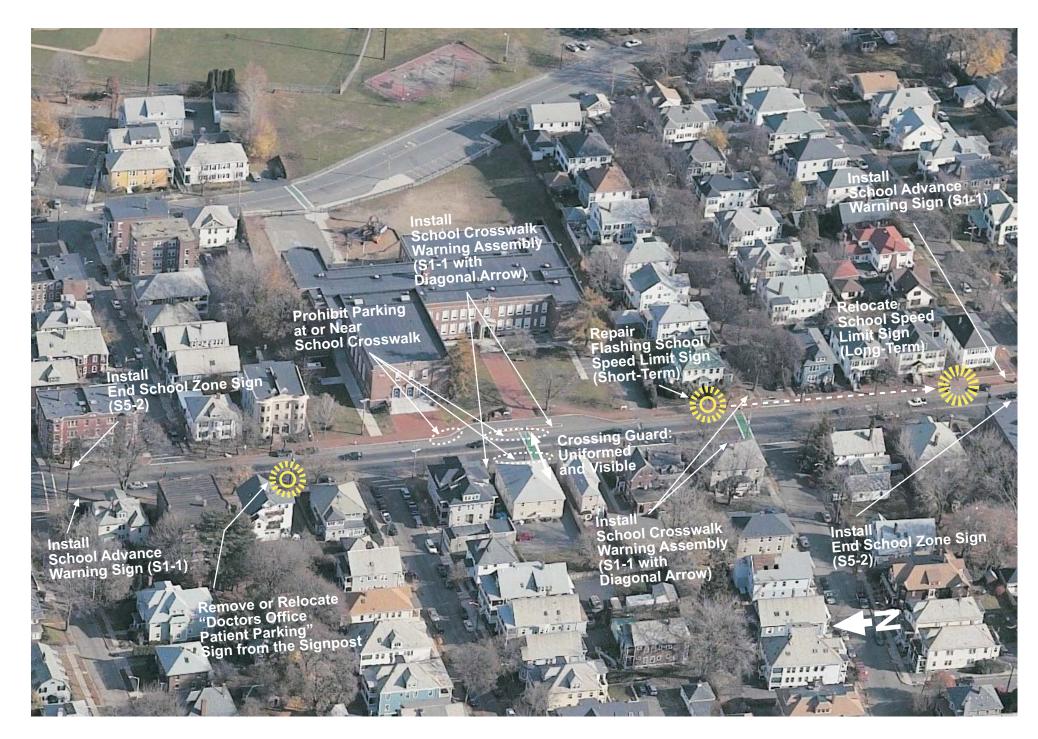
Figure 3 Proposed Improvements

The school's arrangement of drop-offs and pick-ups on Salem Street is appropriate, as it promotes student safety, reduces traffic conflicts, and minimizes traffic delay on Lafayette Street. The number of students observed crossing Lafayette Street is relatively low. At this time, CTPS does not recommend the installation of a traffic signal at the midblock school crossing. Usually other remedial measures, such as school advance warning signs and crossing guards, should be considered before the installation of a traffic signal.⁴ The recommended improvements are listed below, and the locations of some of them are illustrated in Figure 3.

- A school crossing guard should be present, uniformed, and visible at the midblock crosswalk during student arrival and departure time. If funding is available, an additional crossing guard can be considered at the Hancock Street crosswalk.

- Repair the flashing school speed limit sign on the south side of the school property and plan to relocate this sign to at least 150 feet south of the existing location.

- Remove or relocate the "Doctors Office Patient Parking" sign that is currently located under the flashing school speed limit sign on the north side of the school property. The school speed limit sign is an important message to motorists. The parking sign mounted right under the speed sign can be distracting to motorists, and it undermines respect for school zone signs.

- Install school advance warning signs (S1-1) in advance of the school speed limit signs in both directions.
- Install end school zone signs (S5-2) on the opposite side of Lafayette Street where the school advance warning signs are located.

- Install school crosswalk warning assembly (S1-1 with diagonal arrow) on both sides of the two crosswalks in the school zone.
- Prohibit parking at or near the midblock crosswalk, including the separator island at the pull-out area in front of the school.
