ROUTE 203

(Gallivan Boulevard and Morton Street)

**Safety, Mobility, and
Access Management**

November 2012

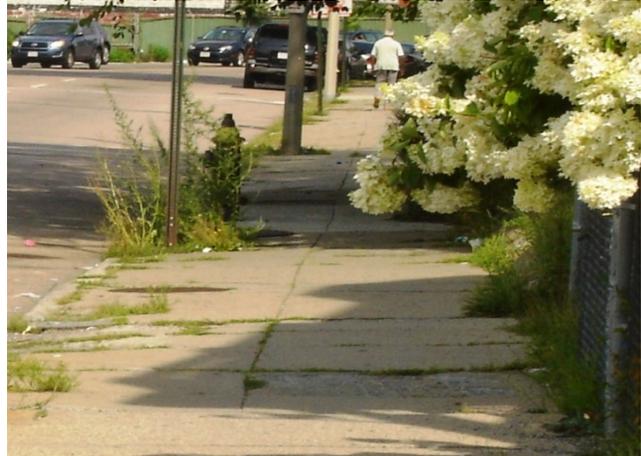
Morton Street, west of Norfolk Street: Sidewalk broken and vegetation has reduced the effective width of the sidewalk

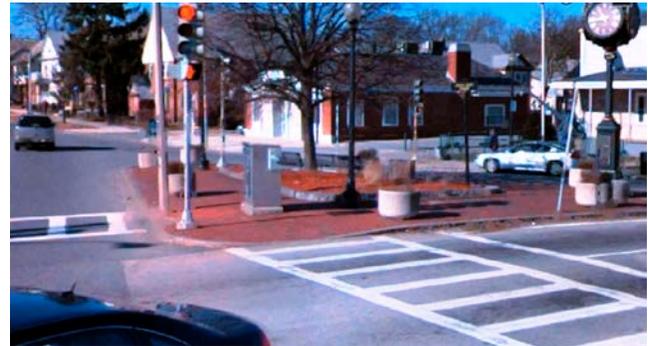
Gallivan Boulevard and Granite Street/Adams Street: Choke points that narrow the effective sidewalk width, such as mailboxes, utility poles and equipment, and landscaping.

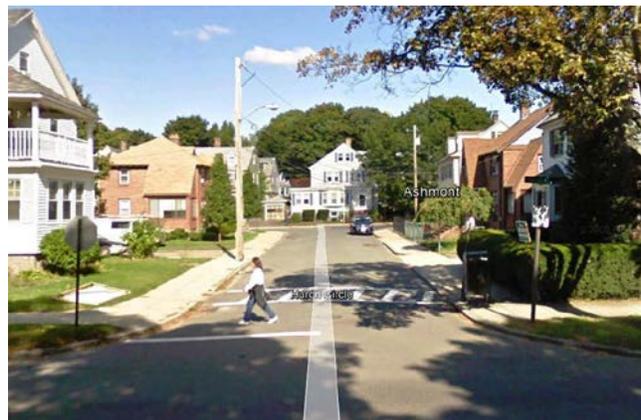
Gallivan Boulevard at Huron Circle: Curb ramps and crosswalk are not aligned to allow pedestrians to stay within the bounds of the sidewalk and the pedestrian desire line.

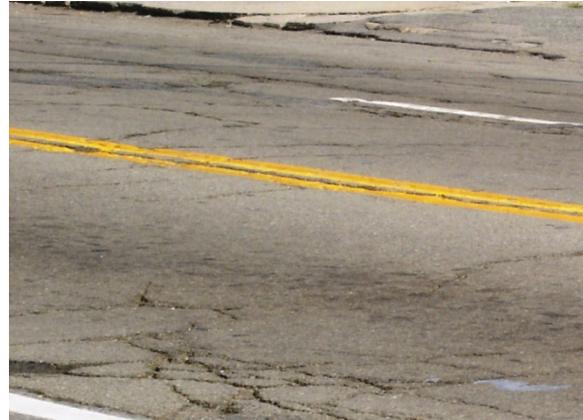
The pavement conditions for Gallivan Boulevard and Morton Street are shown in Figure 3-3. The pavement condition is generally good in the Gallivan Boulevard segment, except for the stretch between Pleasant Hill Avenue and Morton Street, where the pavement condition is poor. In the Morton Street segment, the pavement condition is generally poor. In addition, recent field observations indicate that there are extensive pavement cracking and rutting in the Morton Street segment due to drainage problems and lack of maintenance over the years.

Morton Street, west of Blue Hill Avenue: pavement is broken.

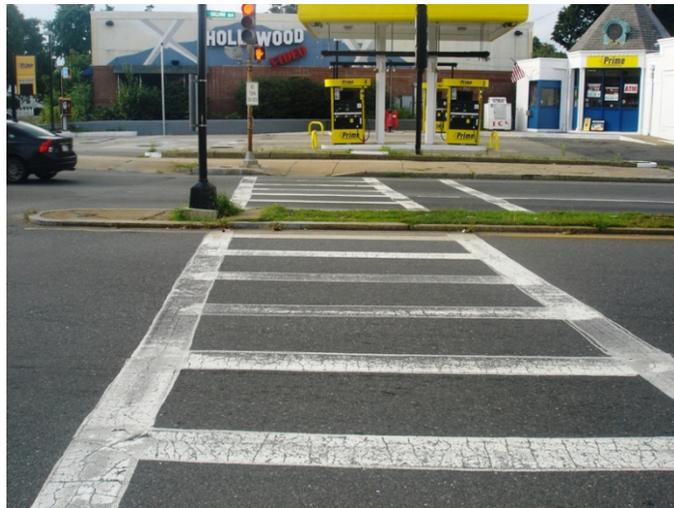
Gallivan Boulevard at Granite Avenue/Adams Street:
No opening in the median to connect the crosswalks

- Construct an opening in the median on the west leg of Gallivan Boulevard to connect the crosswalks and provide a refuge for pedestrians.

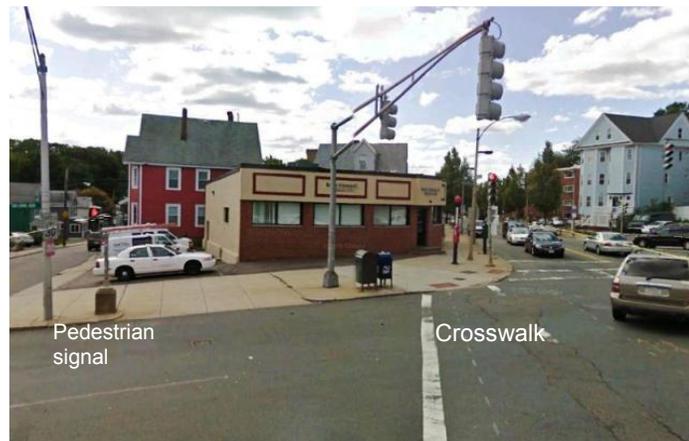
Pedestrian signal not aligned with crosswalk

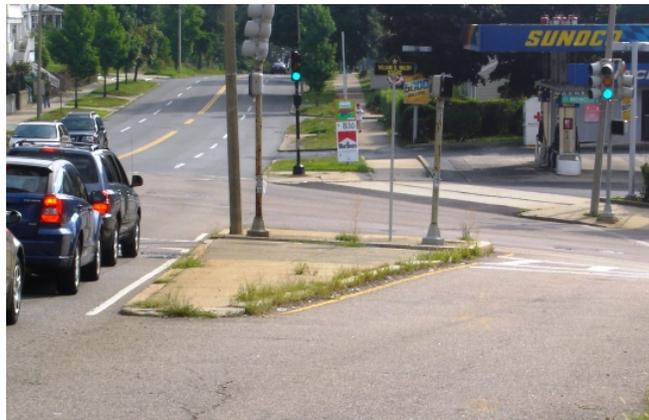
- The post-mounted signal heads do not provide good conspicuity, and the single overhead signal heads on the two Gallivan Avenue approaches are inadequate for two travel lanes (not compliant with MUTCD requirements). In addition, motorists' line of sight to some of the signal post-mounted signal heads may be blocked by trucks in the traffic stream.
- The 11-second pedestrian clearance interval is inadequate for crossing the north leg of Washington Street.
- There are no detectable warning panels at the end of the curb ramps at the intersection.
- There is no OM1-2 (object marker) sign installed at the approach of the triangular island separating the eastbound Gallivan Boulevard through lanes from the channelized right-turn lane.

No object marker (OM1-2) installed at the approach of the triangular island

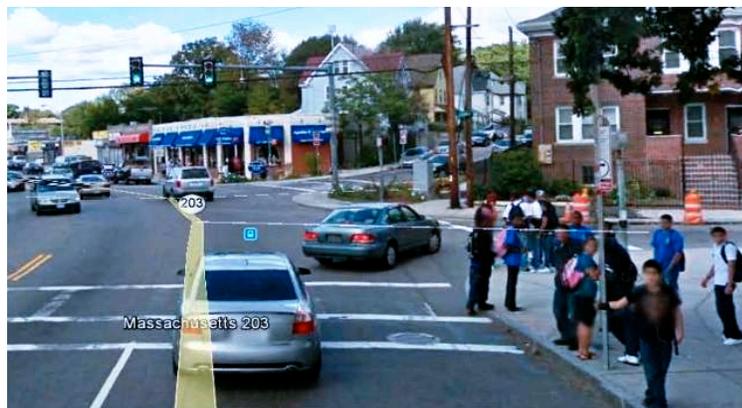
MBTA bus Routes 21 and 26 have stops at the intersection; the stop at Selden Street has 246 total daily boardings and the stop at West Selden Street has 140 total boardings. The MBTA has installed bus stop signs at the intersection. There are no bus shelters or benches at any of the stops in the vicinity of the intersection even though the total daily boardings meet the MBTA criteria for bus shelter installation.

Morton Street at West Selden Street and Corbet Street:
Students and passengers waiting for a school bus or MBTA bus.
