6 Framingham

6.2 STUDY AREA

**FIGURE 6-2
Downtown Framingham
Existing Conditions**

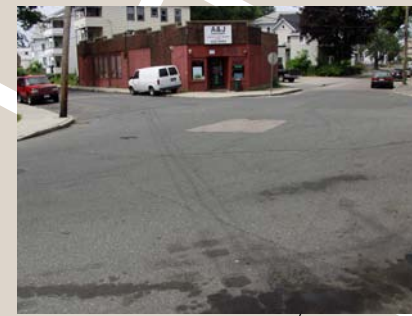
Lack of crosswalks

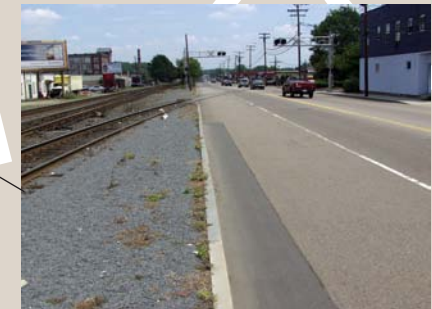
Potential for bike lanes

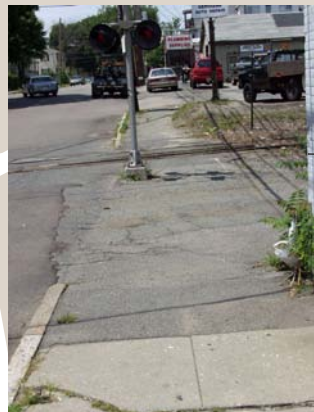
Disrepair near railroad tracks

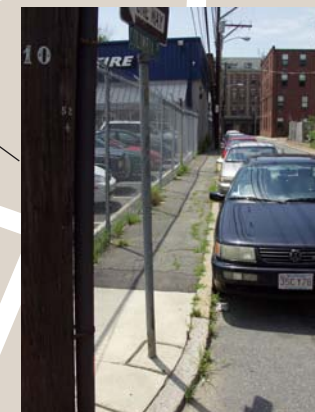
Narrow, obstructed sidewalk
