7. BUS TRANSIT IMPROVEMENTS

*Route 60 Mobility Study:
 Malden and Medford*

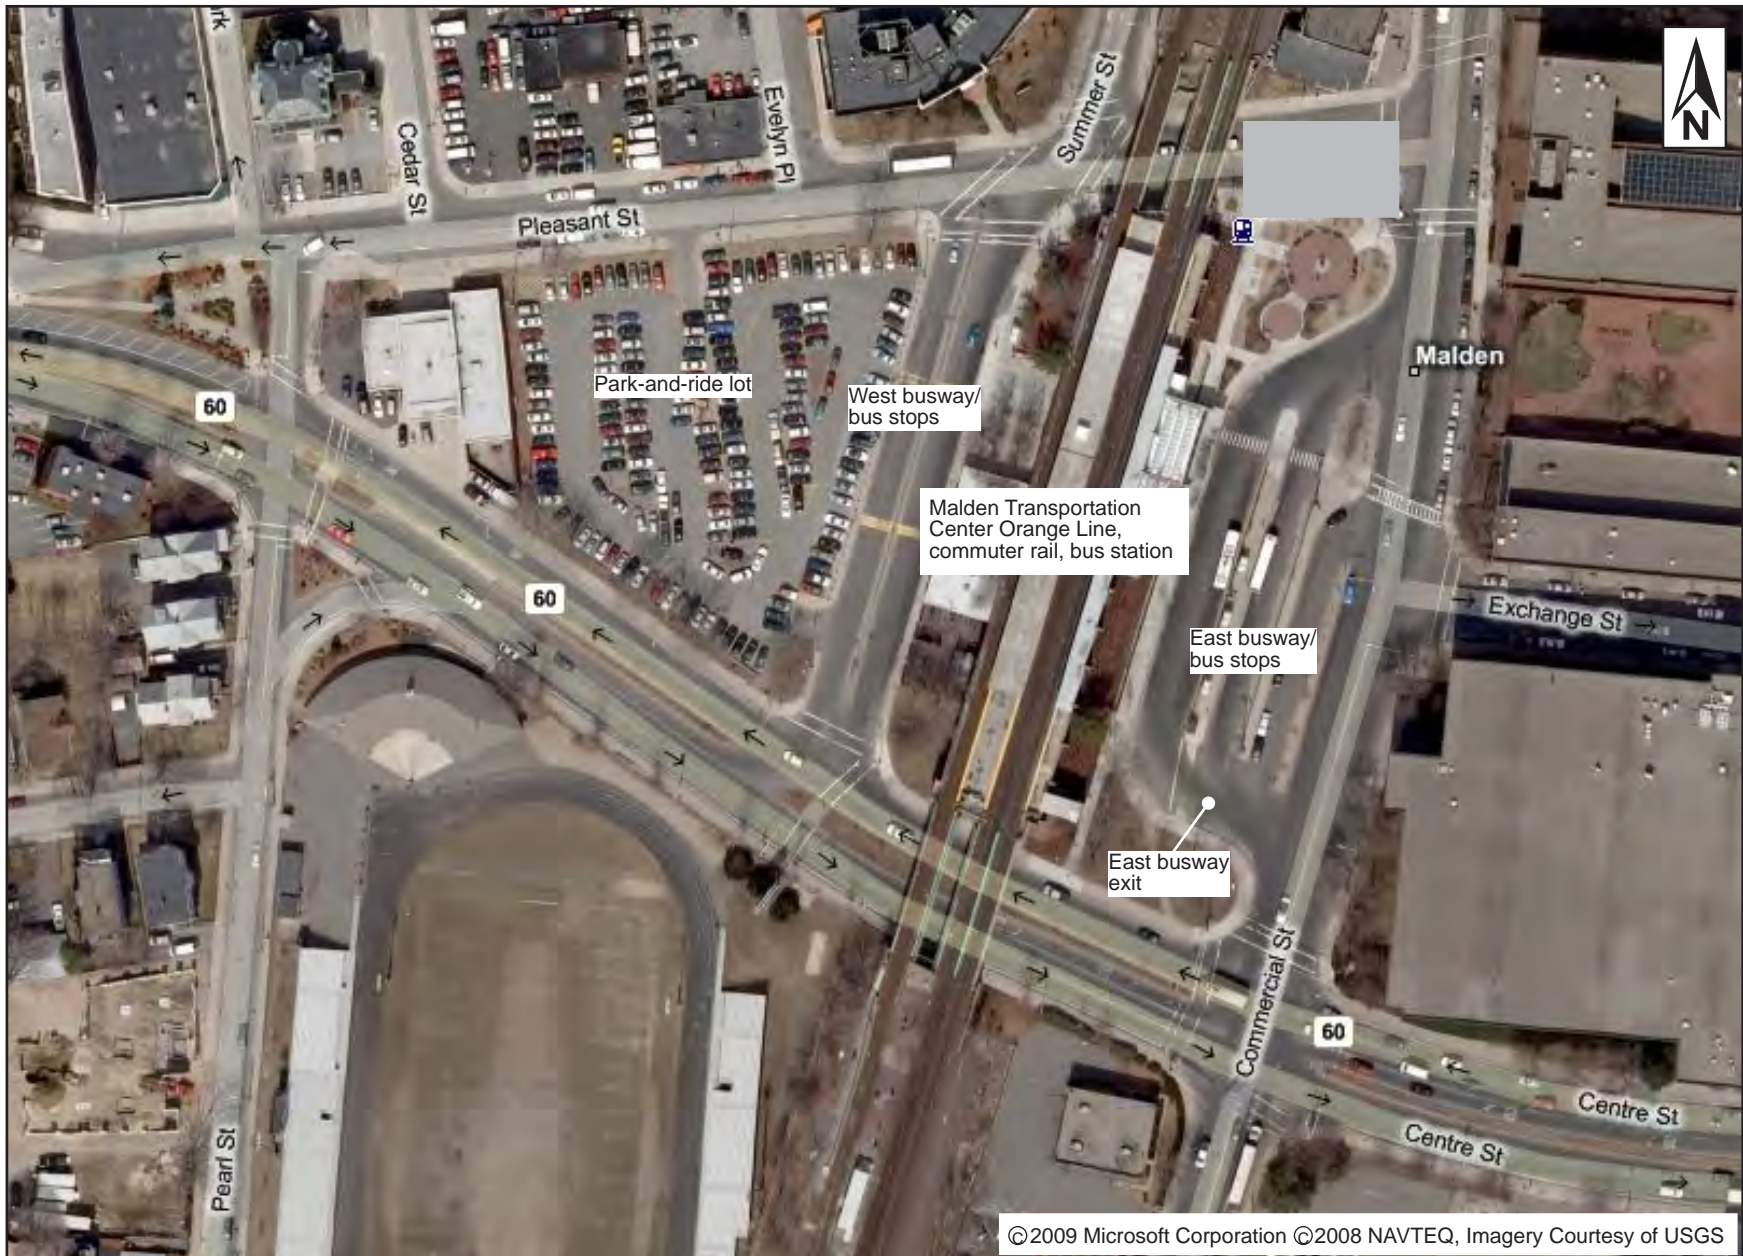
FIGURE 24
Malden Transportation Center

Pedestrian and bicycle needs are important considerations for the Route 60 corridor because of the high density of destinations, such as transit services, supermarkets, restaurants, schools, residences, and other businesses, along Route 60 in Malden and Medford. The Malden Transportation Center is the main transportation hub in the area; it is served by the MBTA Orange Line rapid transit, commuter rail, and buses, making it a multimodal transportation center (see Figure 24). The Malden Transportation Center was recently updated as part of an accessibility improvement program.⁹ As part of the Center's accessibility improvement project, the MBTA constructed concrete wheelchair ramps on the west side of the station. The MBTA also replaced the existing sidewalk and wheelchair ramps at the ends of the crosswalks along the MBTA busway at the end of Pleasant Street, the two midblock crosswalks, and the entrance to the station on Centre Street.

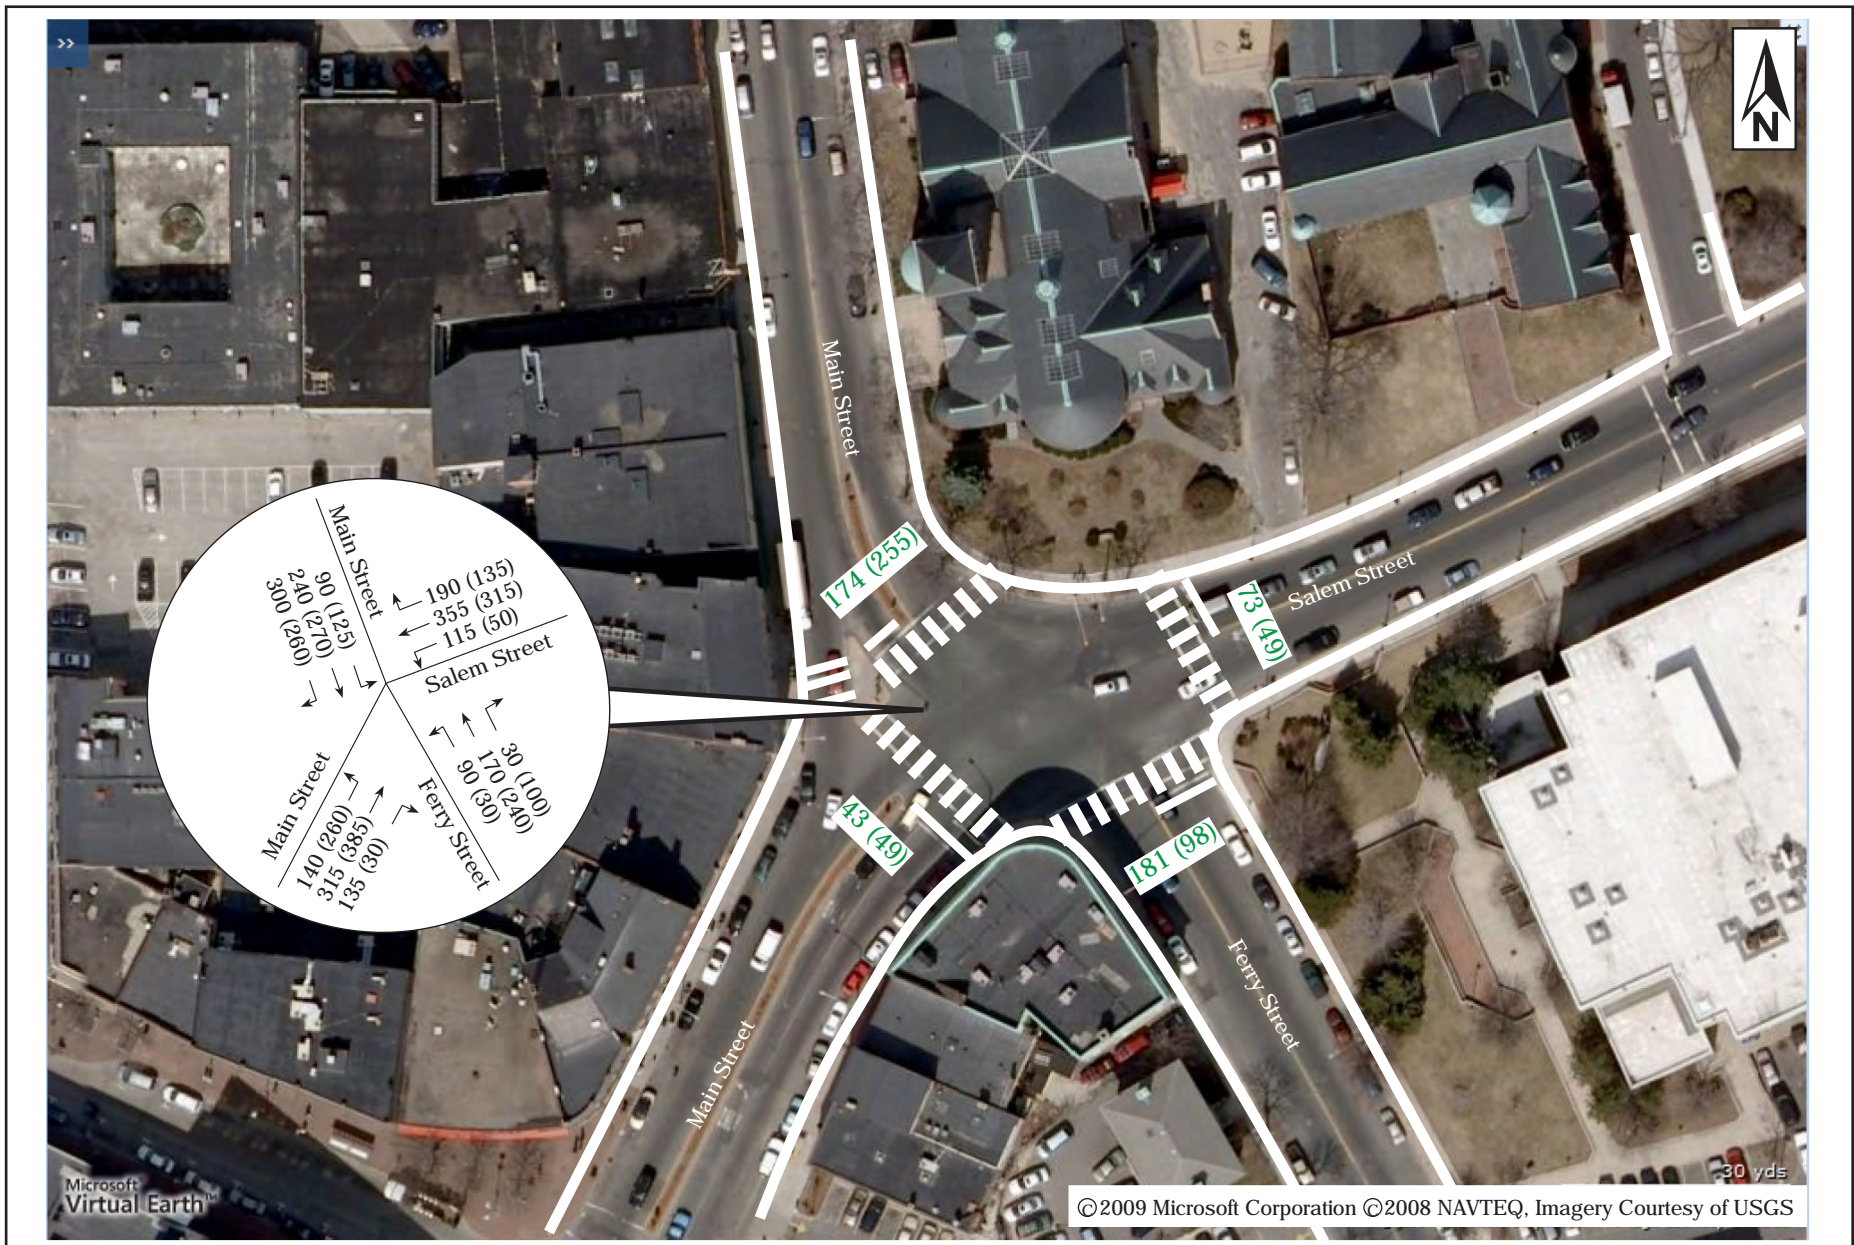
FIGURE 27
 Pedestrian and Vehicular Volumes at the
 Main Street, Salem Street, and Ferry Street Intersection in Malden

Traffic signal coordination is suggested for the abovementioned signals except for the intersection Salem Street and Park Street in Medford, which is an isolated signalized intersection. The first five signalized intersections were already part of the list of study intersections suggested by municipal officials as locations with pedestrian and vehicular safety and operations problems. The last three intersections were added to the study later on to improve bus circulation at the station area, particularly in the loop consisting of Centre Street, Main Street, Florence Street, and Commercial Street (see Figure 25). Figures 27 through 29 show the traffic volumes and pedestrian counts for the three intersections in the loop, where upgrades can be made cost-effectively. The traffic volumes and pedestrian counts were conducted during the peak travel periods, 7:00–9:00 AM and 4:00–6:00 PM.
