# Route 126 Corridor: Transportation Improvement Study Bellingham to Framingham

**Central Transportation Planning Staff** of the **Boston Region Metropolitan Planning Organization**. The MPO is composed of state and regional agencies and authorities, and local governments.

February 2011

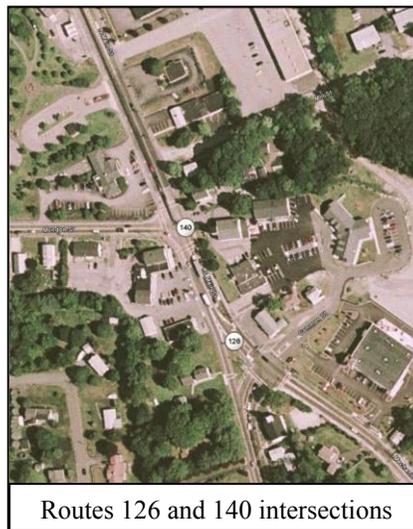
South Main Street, Mechanic Street, North Main Street, and Mendon Street form two closely spaced signalized intersections, shown in the insert at the right. The existing AM and PM peak-hour turning-movement counts are shown in Figure 3-3. Four pedestrians were observed at this intersection during the AM peak period and two pedestrians during the PM peak period. Analysis of the AM and PM peak-hour traffic presented in Table 3-1 indicated that some movements at the approaches of South Main Street and Mechanic Street operate at LOS E or F during the AM or PM peak hours, confirming field observations of queues on these approaches during peak hours.

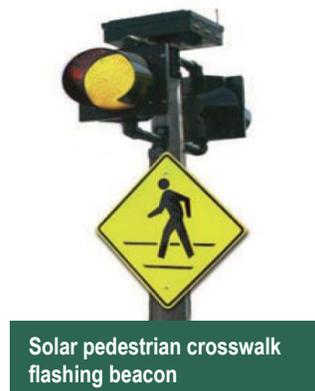
W11-1 and W16-1

- Installation of signs to improve safety for pedestrians and bicyclists. Examples of such signs are nonvehicular warning signs (types W11-2 and W16-7) and bicycle-warning signs (types W11-1 and W16-1).

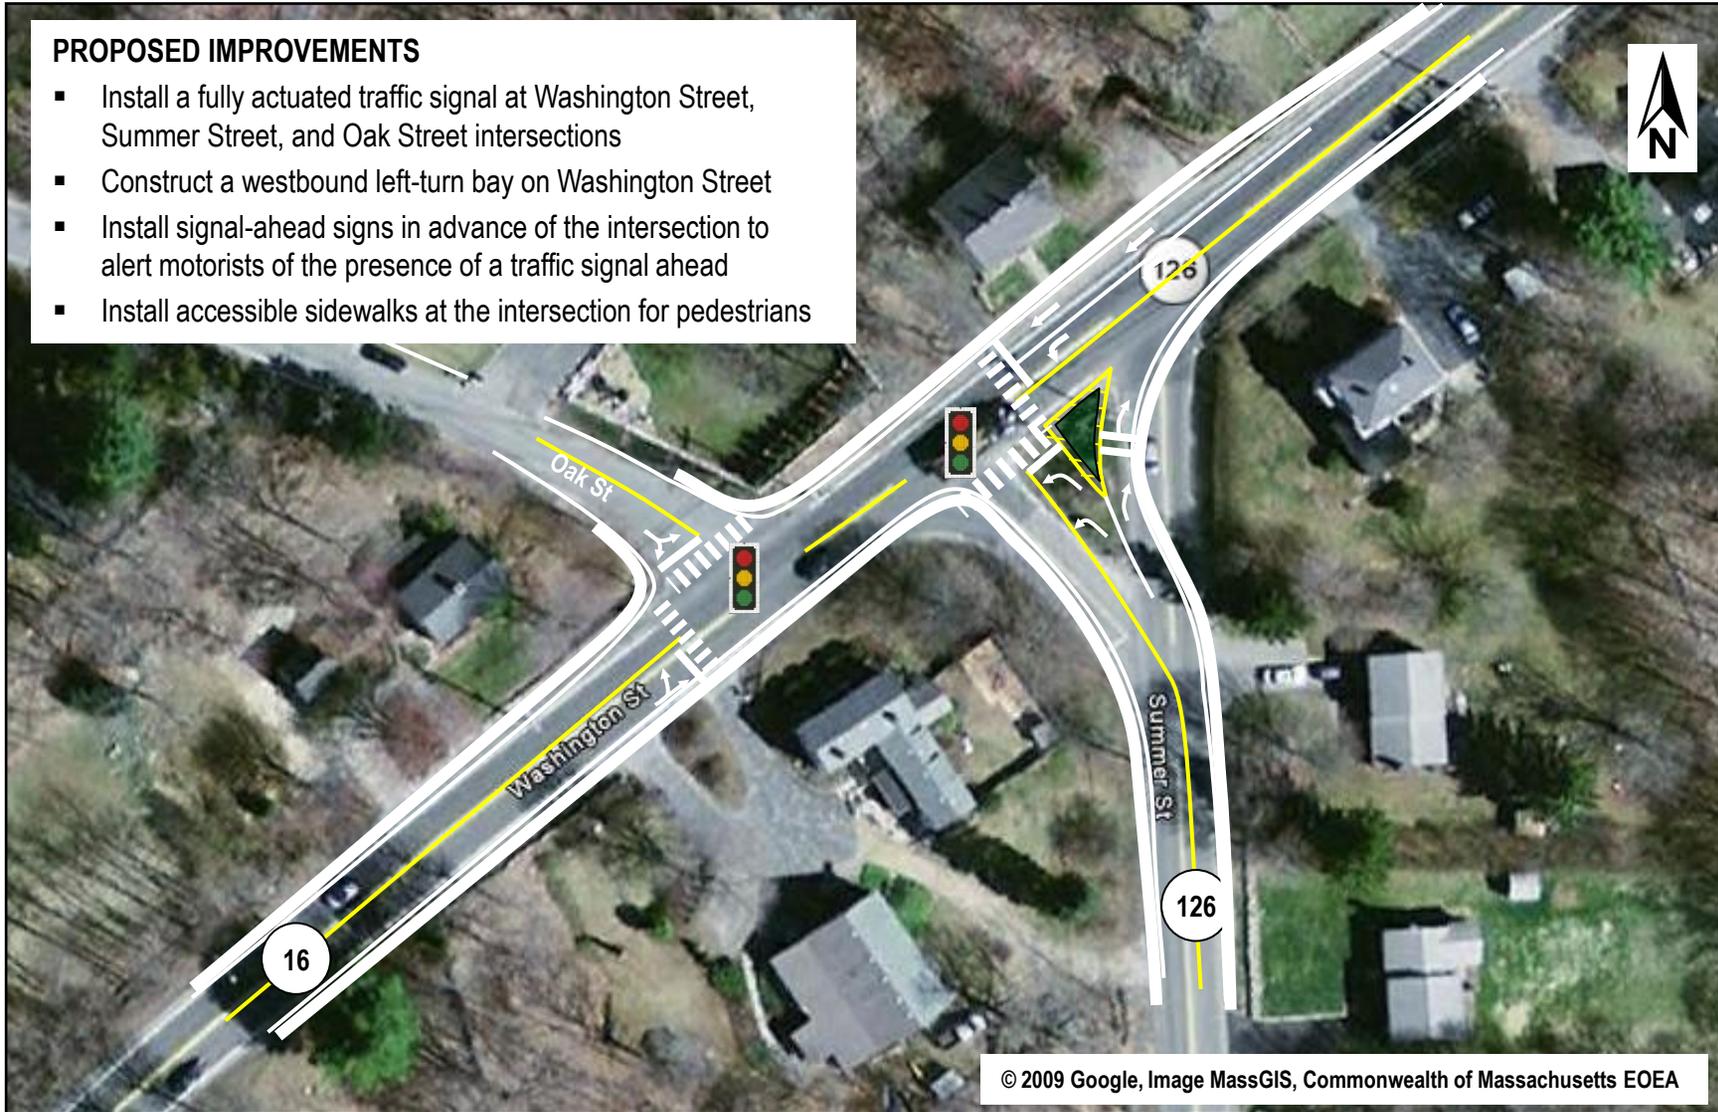
### PROPOSED IMPROVEMENTS

- Install a fully actuated traffic signal at Washington Street, Summer Street, and Oak Street intersections
- Construct a westbound left-turn bay on Washington Street
- Install signal-ahead signs in advance of the intersection to alert motorists of the presence of a traffic signal ahead
- Install accessible sidewalks at the intersection for pedestrians

- Installation of a new traffic signal with pedestrian signals that are activated by push buttons at the intersection of Washington Street, Summer Street, and Oak Street. Installation of signal-ahead signs (type W3-3) in advance of the intersection to alert motorists of the presence of a traffic signal ahead that is obscured by the horizontal and vertical curves in the vicinity that might the limit approach sight distance. Installing a traffic signal at the intersection would reduce congestion, as all movements at the intersection would operate at LOS D or better (Table 5-1).

- Design of geometric improvements at the intersection of Washington Street and Summer Street, including the addition of a westbound left-turn lane on Washington Street and an exclusive right-turn lane on Summer Street, to improve safety and traffic operation (Figure 5-3).

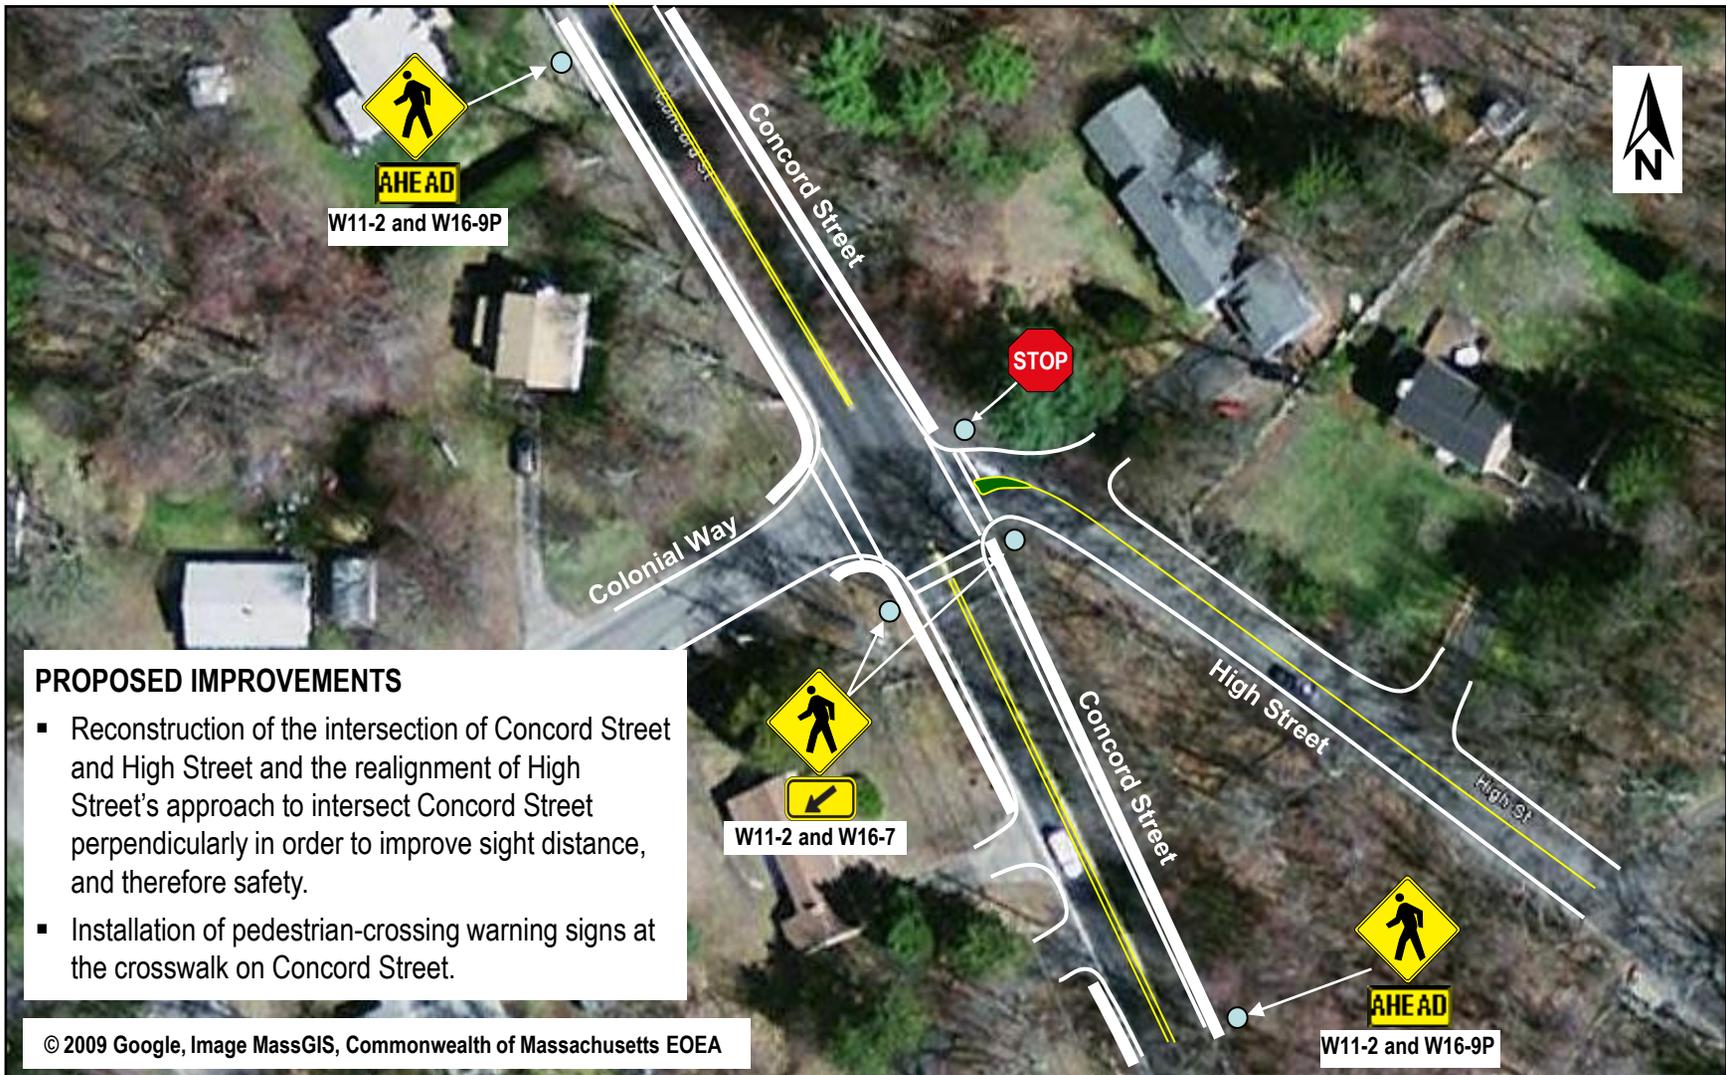
**FIGURE 5-6**  
**Concord Street and High Street Intersection:**  
**Proposed Improvements**

- Realignment of the approach of High Street so that it intersects Concord Street perpendicularly in order to improve sight distance for motorists (see Figure 5-6).

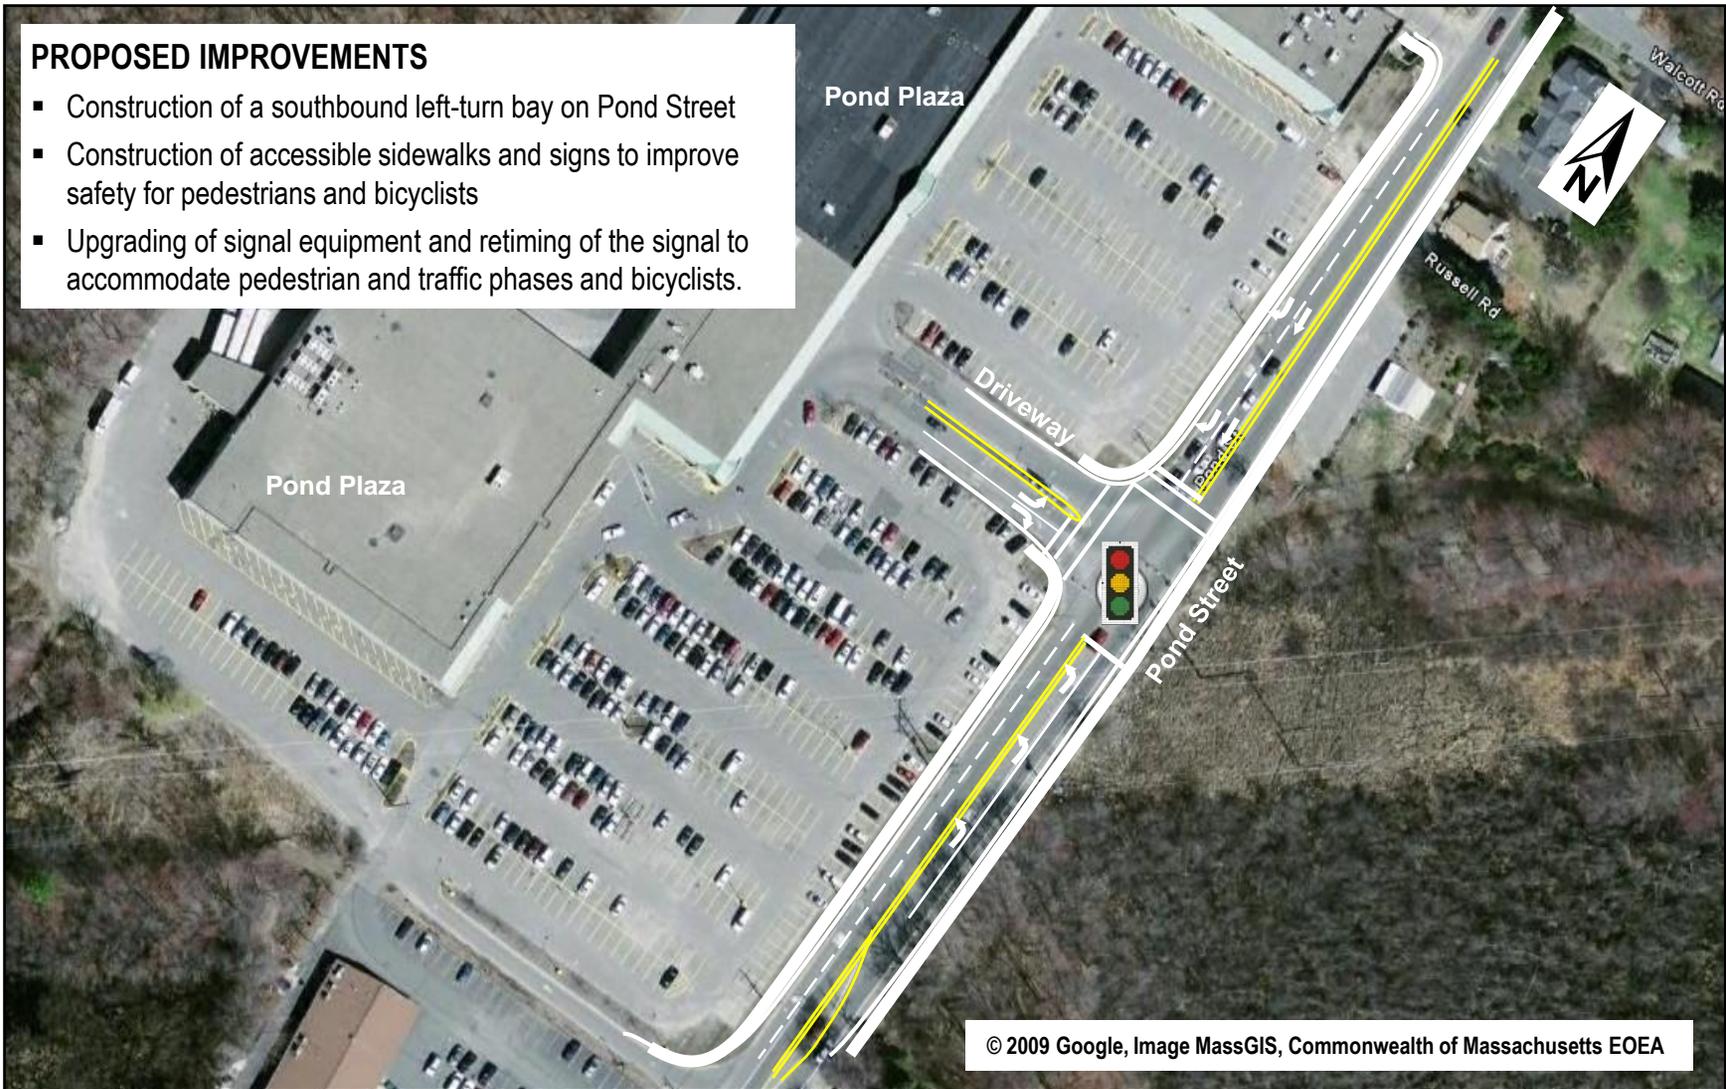
**FIGURE 6-6**  
**Pond Street and Pond Plaza Driveway Intersection:**  
**Proposed Improvements**

### PROPOSED IMPROVEMENTS

- Construction of a southbound left-turn bay on Pond Street
- Construction of accessible sidewalks and signs to improve safety for pedestrians and bicyclists
- Upgrading of signal equipment and retiming of the signal to accommodate pedestrian and traffic phases and bicyclists.
