ROUTE 203

(Gallivan Boulevard and Morton Street)

**Safety, Mobility, and
Access Management**

November 2012

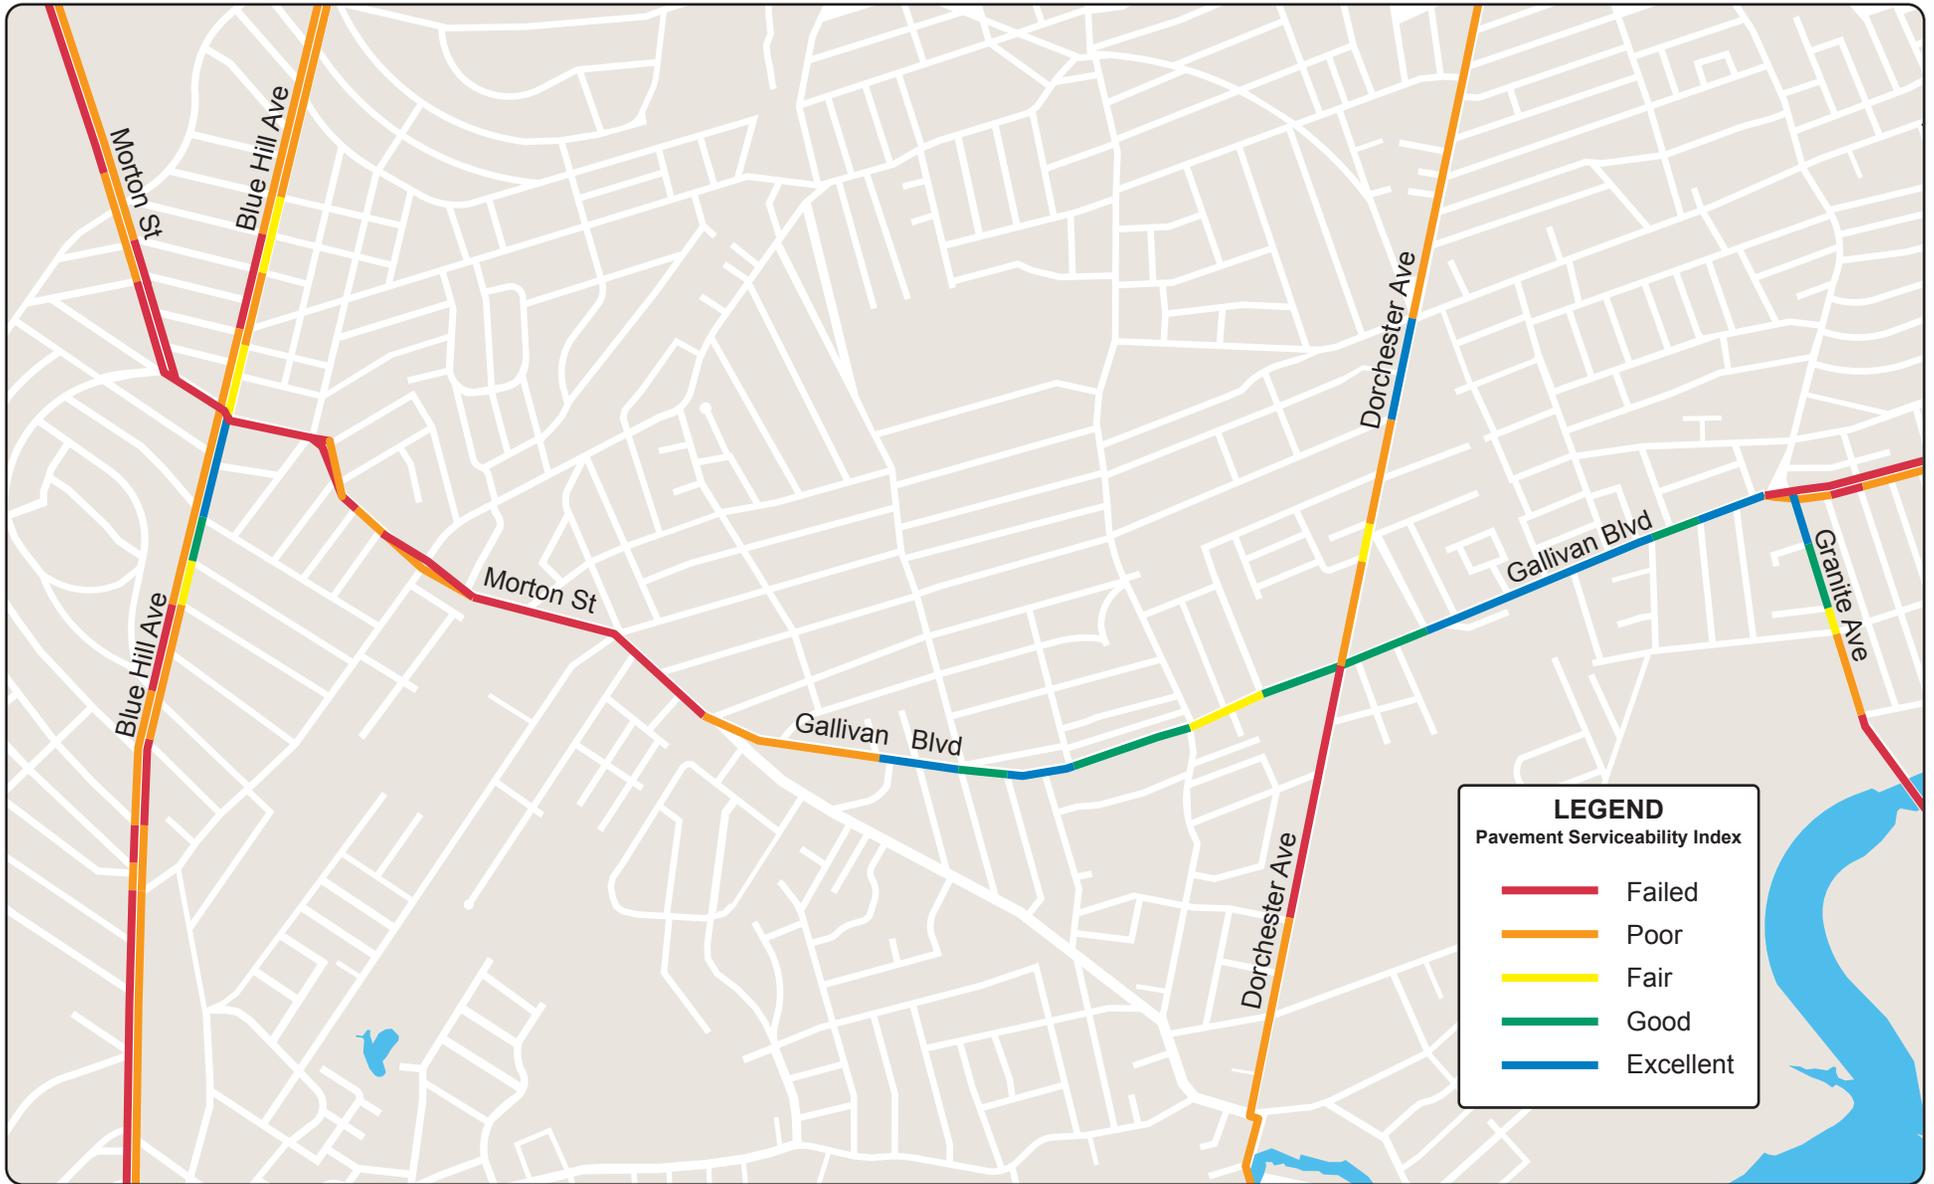
FIGURE 3-3
Pavement Condition

The pavement conditions for Gallivan Boulevard and Morton Street are shown in Figure 3-3. The pavement condition is generally good in the Gallivan Boulevard segment, except for the stretch between Pleasant Hill Avenue and Morton Street, where the pavement condition is poor. In the Morton Street segment, the pavement condition is generally poor. In addition, recent field observations indicate that there are extensive pavement cracking and rutting in the Morton Street segment due to drainage problems and lack of maintenance over the years.
