# Route 60 Mobility Study: Malden and Medford, Massachusetts

Boston Region Metropolitan Planning Organization

September 2009

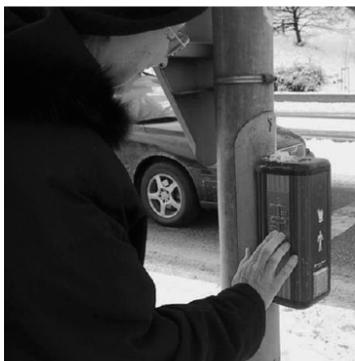
Accessible pedestrian signal

Accessible pedestrian signals (APS), which operate concurrently with visual pedestrian signals, provide audible and/or vibrotactile information to inform visually impaired pedestrians precisely when the “WALK” interval begins and when it is no longer safe to cross. Audible signals also provide directional guidance, which is particularly useful at multilane crossings. Audible signals actuated by push buttons are the most commonly used type of APS, and they often emit a chirping or “cuckoo” tone during the “WALK” interval.

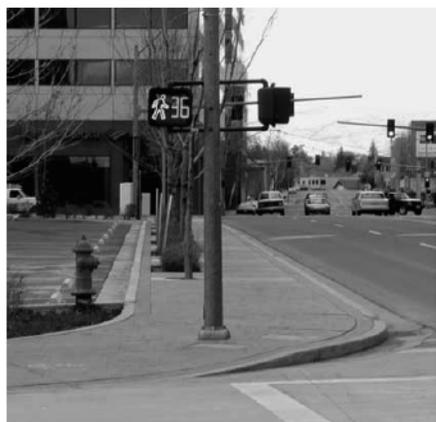
Countdown pedestrian signal

construed as positive, since it would seem that more pedestrians get out of the crosswalk before the nonflashing “DON’T WALK” signal comes on when there is a countdown signal. Thus, pedestrians are using the additional information provided by the countdown signal to complete their crossing in the time provided. Completing a crossing before the nonflashing “DON’T WALK” signal comes on reduces the chances of pedestrians encountering conflicting vehicle movements.

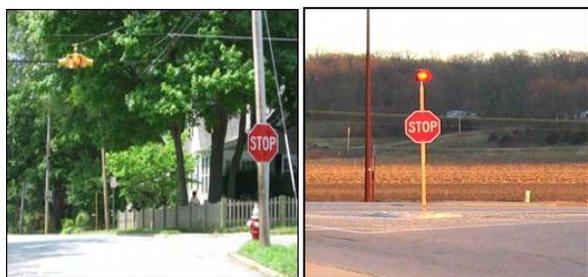
Standard overhead flashing beacon

Post-mounted flashing beacon with stop sign

facing the Hadley Place stop-controlled approach and yellow flashers facing the Salem Street uncontrolled approaches. Use of flashing beacons increases the visibility of intersections for approaching drivers, thus supplementing the signage and marking improvements and calling attention to stop signs.

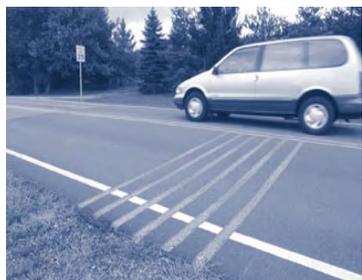
**Rumble strips**

The Salem Street and Hadley Place intersection is about 150 feet east of the I-93 interchange; thus crashes may occur because one or more drivers may be unaware of the intersection as it is so close to the interchange. Installing rumble strips at the approaches would call attention to the presence of the intersection and the traffic control in use at the intersection. Rumble strips are appropriate on stop-controlled approaches to intersections where a pattern of crashes is related to the drivers' lack of attention to certain traffic activity, control measures, or a change in the geometry of the intersection.

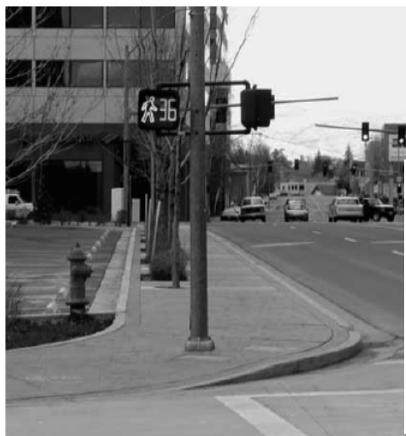
Countdown pedestrian signal

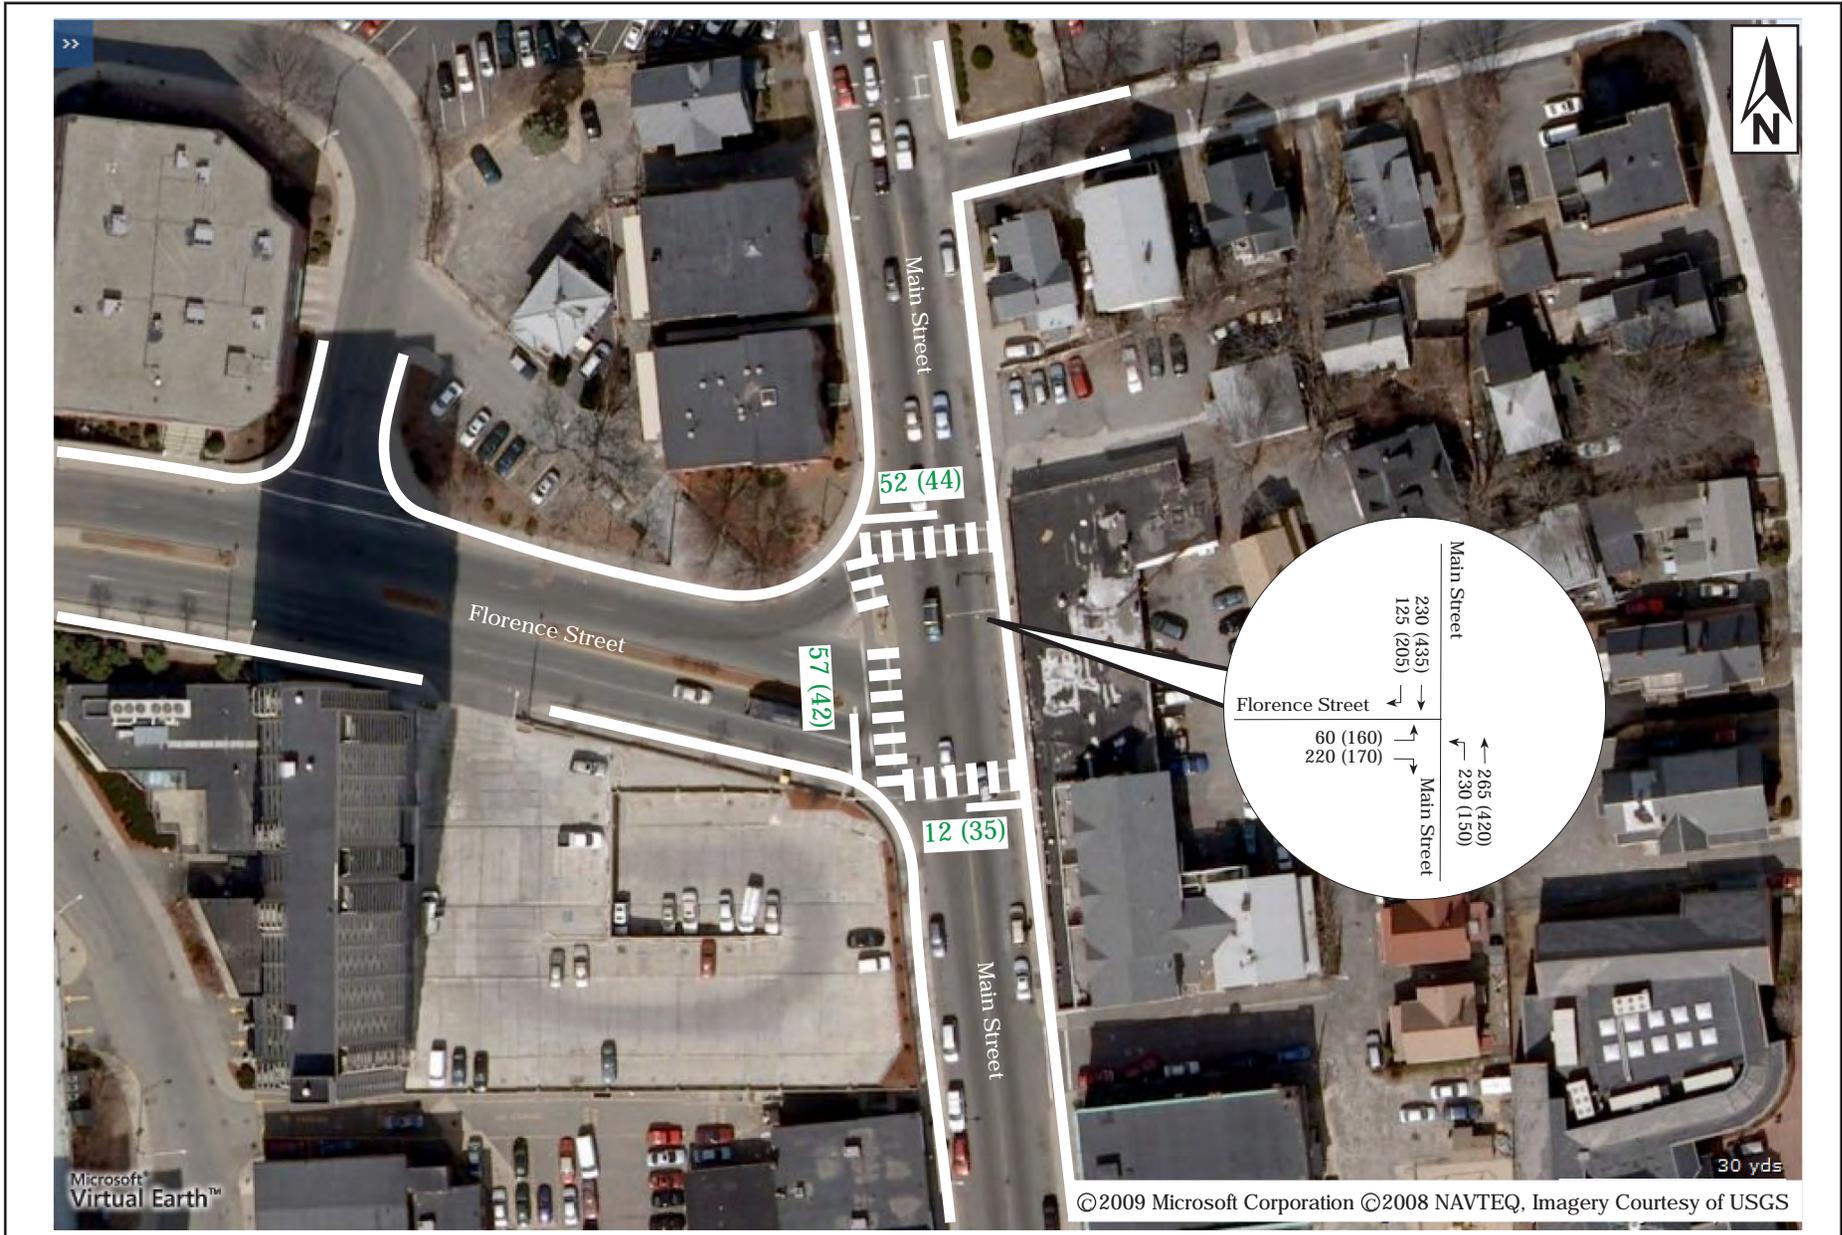
**FIGURE 29**  
 Pedestrian and Vehicular Volumes at the  
 Main Street and Florence Street Intersection in Malden

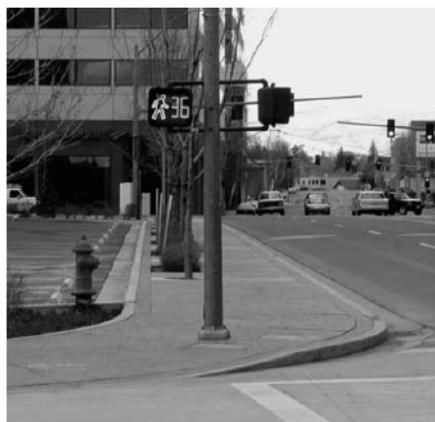
Countdown pedestrian signal

Accessible pedestrian signals (APS), which operate concurrently with visual pedestrian signals, provide audible and/or vibrotactile information to inform visually impaired pedestrians precisely when the “WALK” interval begins and when it is no longer safe to cross. Audible signals also provide directional guidance, which is particularly useful at multilane crossings. Audible signals actuated by push buttons are the most commonly used type of APS, and they often emit a chirping or “cuckoo” tone during the “WALK” interval.

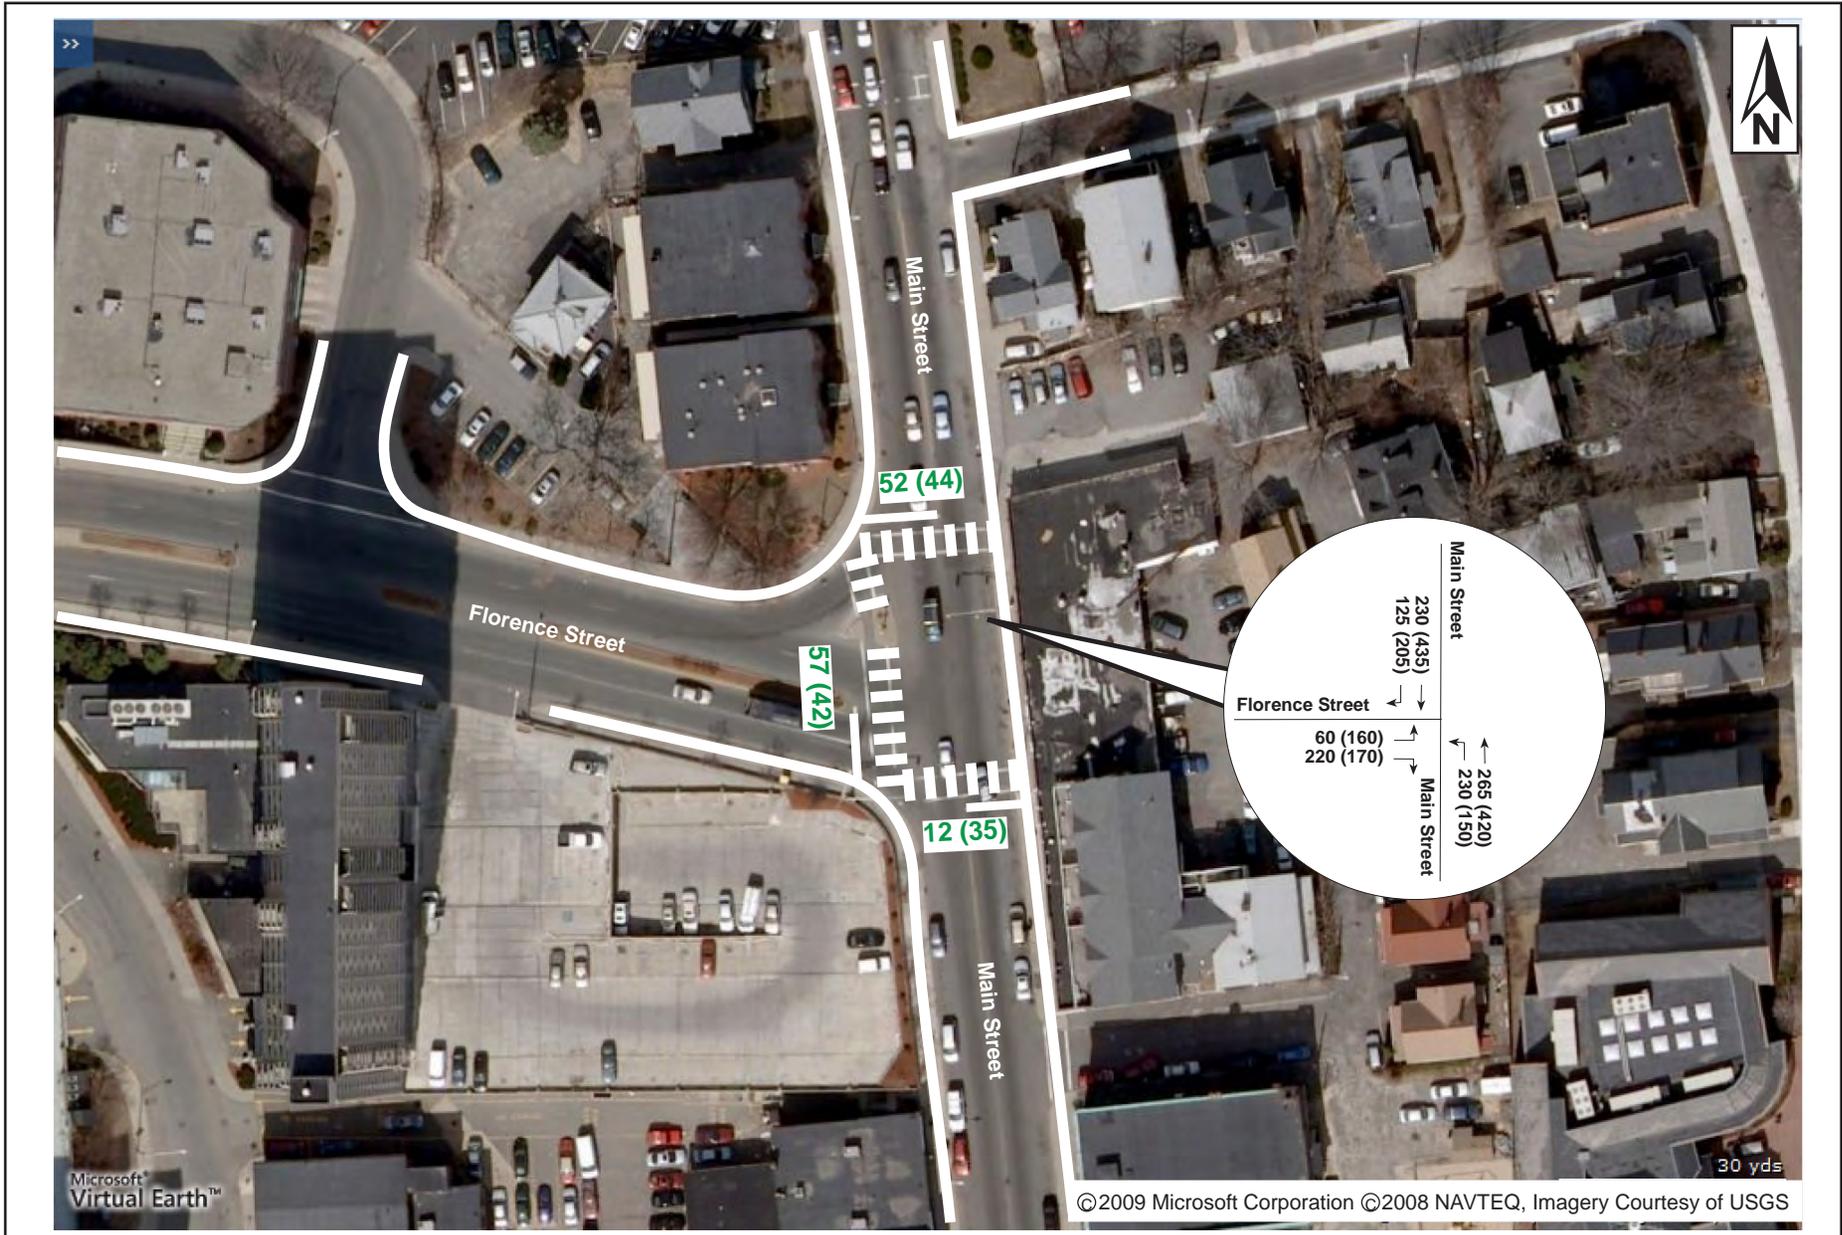
**FIGURE 29**  
**Pedestrian and Vehicular Volumes at the**  
**Main Street and Florence Street Intersection in Malden**
