Appendix B

Pedestrian and Bicycle Report Cards

Pedestrian Report Card Assessment (PRCA): Roadway Segment

Route 1 in Norwood: Existing Conditions

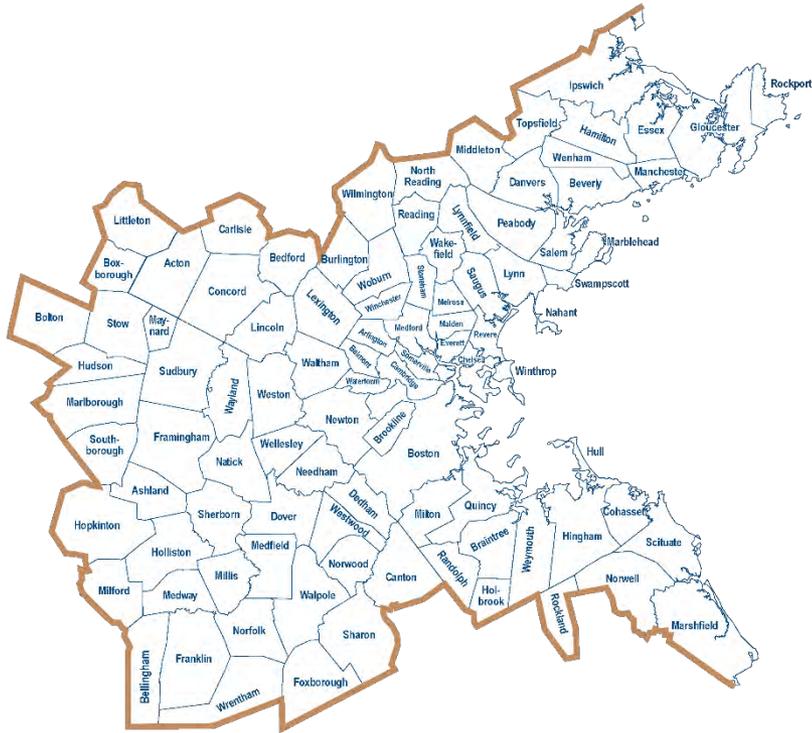
Roadway Segment Location

Grading Category	Performance Measure	Features of Analyzed Locations
Capacity Management and Mobility	Sidewalk Presence	Large gaps in sidewalk network
	Crosswalk Presence	Roadway with fewer than seven crosswalk per mile
	Walkway Width	Roadway segment with less than half of the sidewalks measuring at least five feet wide
Economic Vitality	Pedestrian Volumes	Roadway segment traversed by five to 60 pedestrians per hour
	Adjacent Bicycle Accommodations	Roadway segments without space for bicycle travel
Safety	Pedestrian Crashes	Roadway segment with two pedestrian crashes
	Pedestrian-Vehicle Buffer	Roadway segments with a 5- to 10-foot buffer
	Vehicle Travel Speed	Roadway segments where average vehicle travel speed is 45 miles per hour or more
System Preservation	Sidewalk Condition	Roadway segments with less than half of sidewalks in good condition

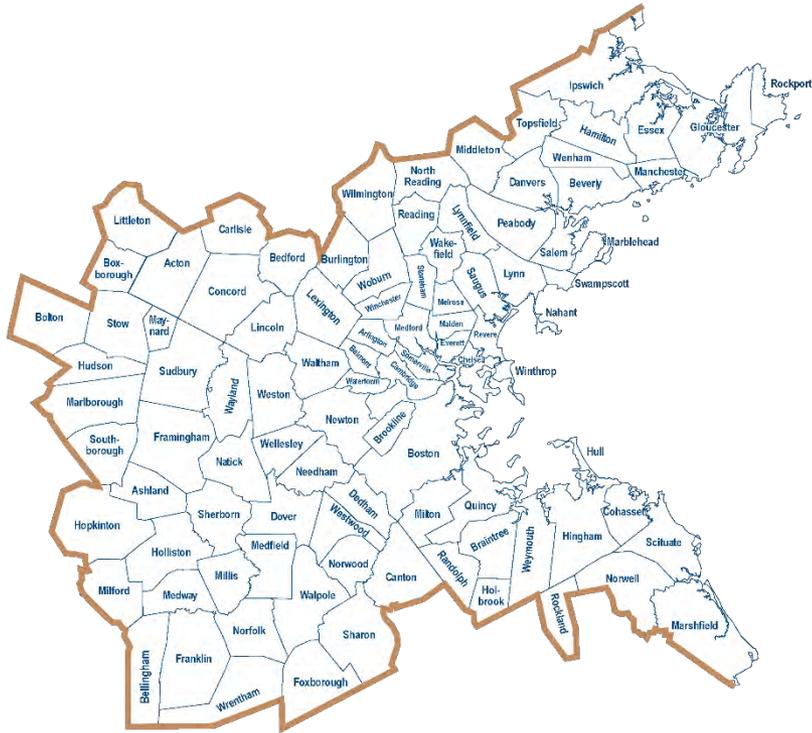
Roadway Segment Location

Route 1 in Norwood: With improvements

Grading Category	Performance Measure	Features of Analyzed Locations
Capacity Management and Mobility	Sidewalk Presence	Propose improvements close all gaps in sidewalk network
	Crosswalk Presence	Propose improvements adds new crossing opportunities where needed
	Walkway Width	Proposed improvements recommend upgrading sidewalks to MassDOT standards
Economic Vitality	Pedestrian Volumes	Roadway segment traversed by five to 60 pedestrians per hour
	Adjacent Bicycle Accommodations	Proposed improvements add sidewalk-level or street-level separated bike lanes in the study corridor
Safety	Pedestrian Crashes	Proposed improvements improves accommodations for people who walk or bike
	Pedestrian-Vehicle Buffer	Proposed improvements add separated bike lanes on Route 1
	Vehicle Travel Speed	Roadway segments where average vehicle travel speed is 45 miles per hour or more
System Preservation	Sidewalk Condition	Proposed improvements add new sidewalks on Route 1

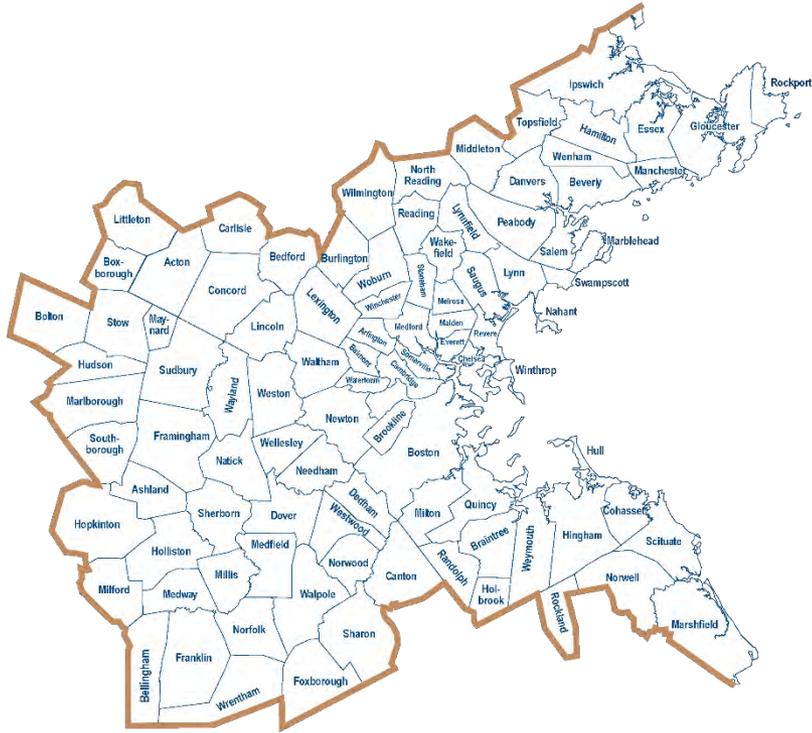
Roadway Segment Location

Route 1 in Norwood: Existing Conditions

Goal	Performance Measure	Features of Analyzed Locations
Capacity Management and Mobility	Bicycle Facility Presence	None in the corridor, people biking mostly stay on the shoulder
	Proximity to Bike Network	No bicycle facility within one-quarter mile
	Proximity to Transit	Yes, bus route 34E, commuter rail stations Norwood Center, Norwood Depot, and University Station are within one-half mile of the study area
Economic Vitality	Bike Rack Presence	None in the corridor
	Land Use	Land uses in the corridor, including commercial and retail, residential, and recreational, would support biking
Safety	Bicycle Facility Presence	None in the corridor
	Absence of Bicycle Crashes	Two bicycle crashes in five years (2014–19)
	Bicyclist Operating Space	People biking mostly stay on the shoulder, but sometimes have to share lane with vehicles at locations where a right-turn lane uses up the shoulder
	Number of Travel Lanes	Two travel lanes each direction

System Preservation	Bicycle Facility Continuity	No bicycle facility
	Bicycle Facility Condition	No bicycle facility

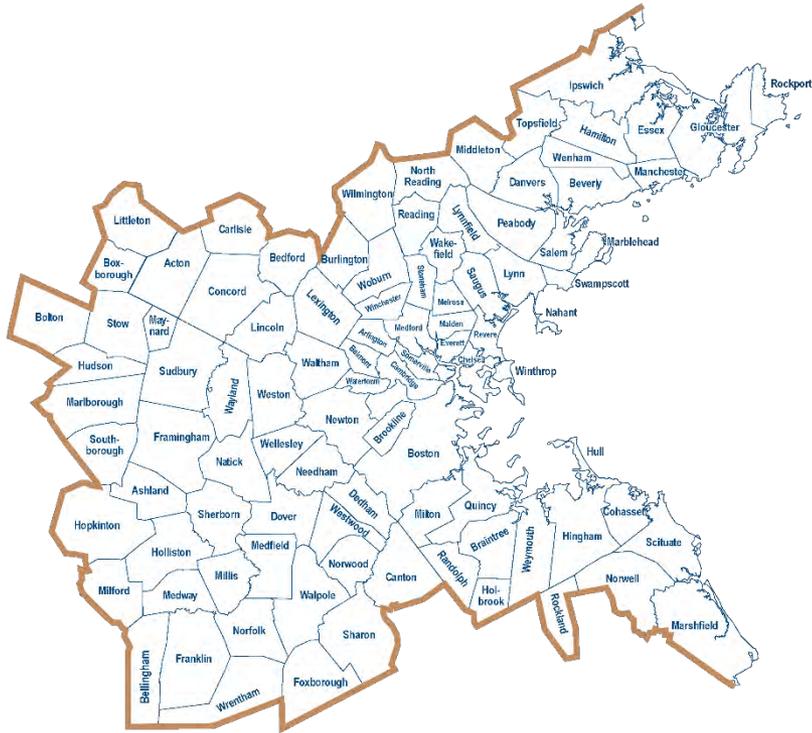
Roadway Segment Location

Route 1 in Norwood: With Improvements

Goal	Performance Measure	Features of Analyzed Locations
Capacity Management and Mobility	Bicycle Facility Presence	Proposed improvements has sidewalk- or street-level separated bike lanes
	Proximity to Bike Network	No bicycle facility within one-quarter mile
	Proximity to Transit	Yes, bus route 34E, commuter rail stations Norwood Center, Norwood Depot, and University Station are within one-half mile of the study area
Economic Vitality	Bike Rack Presence	Proposed improvements include bike sharing in the corridor
	Land Use	Land uses in the corridor, including commercial and retail, residential, and recreational, would support biking
Safety	Bicycle Facility Presence	Proposed improvements has sidewalk- or street-level separated bike lanes
	Absence of Bicycle Crashes	Proposed sidewalk- or street-level separated bike lanes will improve safety for people who bike
	Bicyclist Operating Space	Proposed improvements has sidewalk- or street-level separated bike lanes

Number of Travel Lanes	Two travel lanes each direction
System Preservation	Bicycle Facility Continuity	Proposed improvements has sidewalk- or street-level separated bike lanes in the entire corridor
	Bicycle Facility Condition	New sidewalk- or street-level separated bike lanes
